National Register of Historic Places
Inventory—Nomination Form

historic Seguin Commercial Historic District

street & number Roughly bounded by Camp, Myrtle, Washington,
and Crockett Streets. N/A not for publication

state Texas code 048 county Guadalupe code 187

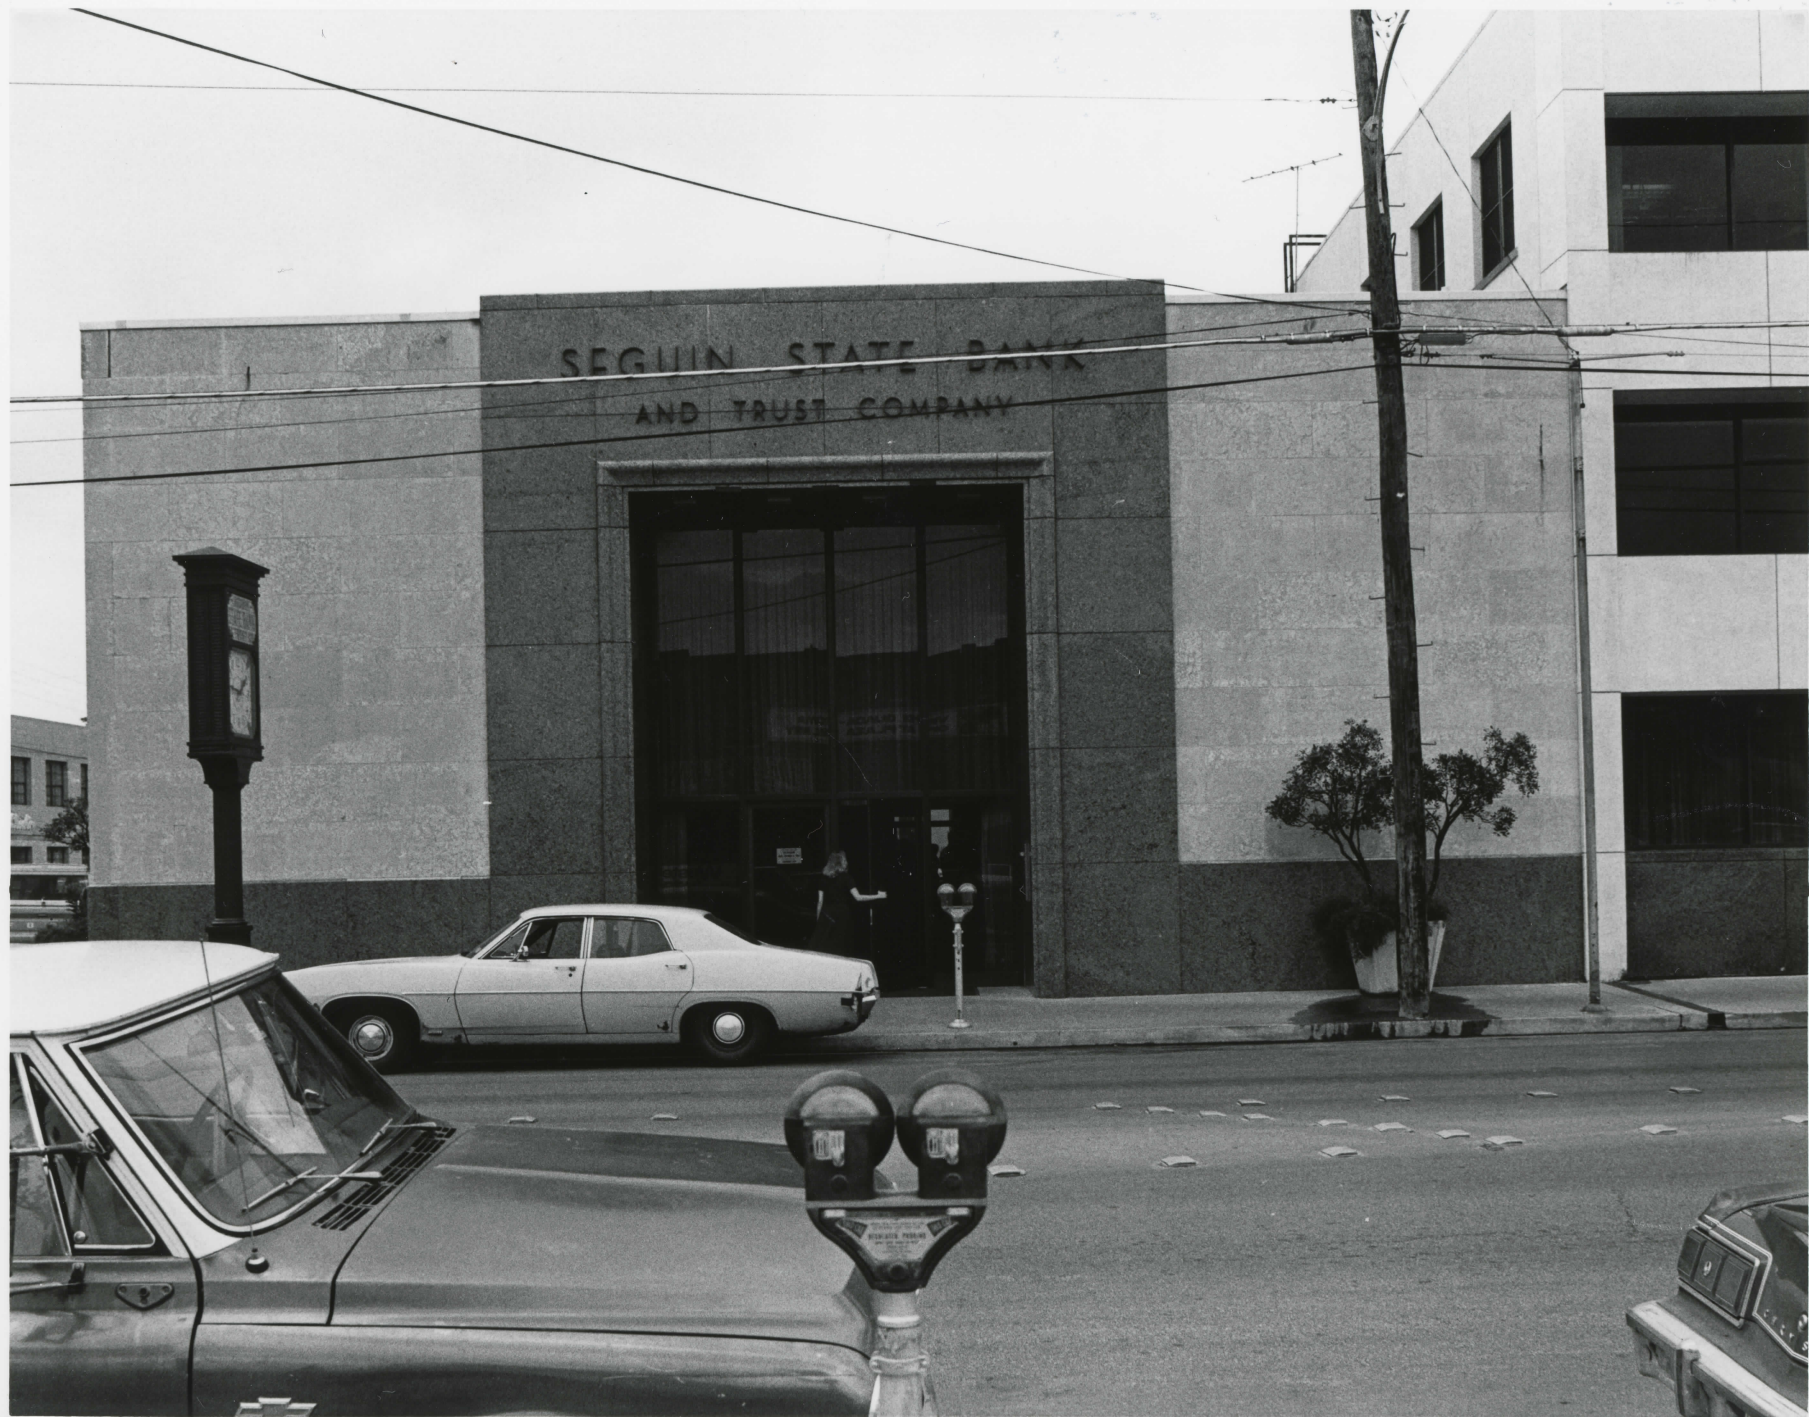
Photo 4 of 19

Site 27a, Seguin State Bank, 200 N. Austin, Seguin,
Guadalupe County, Texas

25. 314 N. River, c. 1900. One-story frame residence. Contributing.
26. 310 N. River, c. 1930. One-story, two-bay-wide brick garage. Noncontributing.
27. Seguin State Bank, 200 N. Austin, 1956. Seguin State Bank and Trust Co. was founded in 1906, acquiring Citizen's State Bank in 1930. The bank has been at this location since 1940. The two-story, granite-faced building with red granite trim carries out the scale and rhythm of the district. Noncontributing.

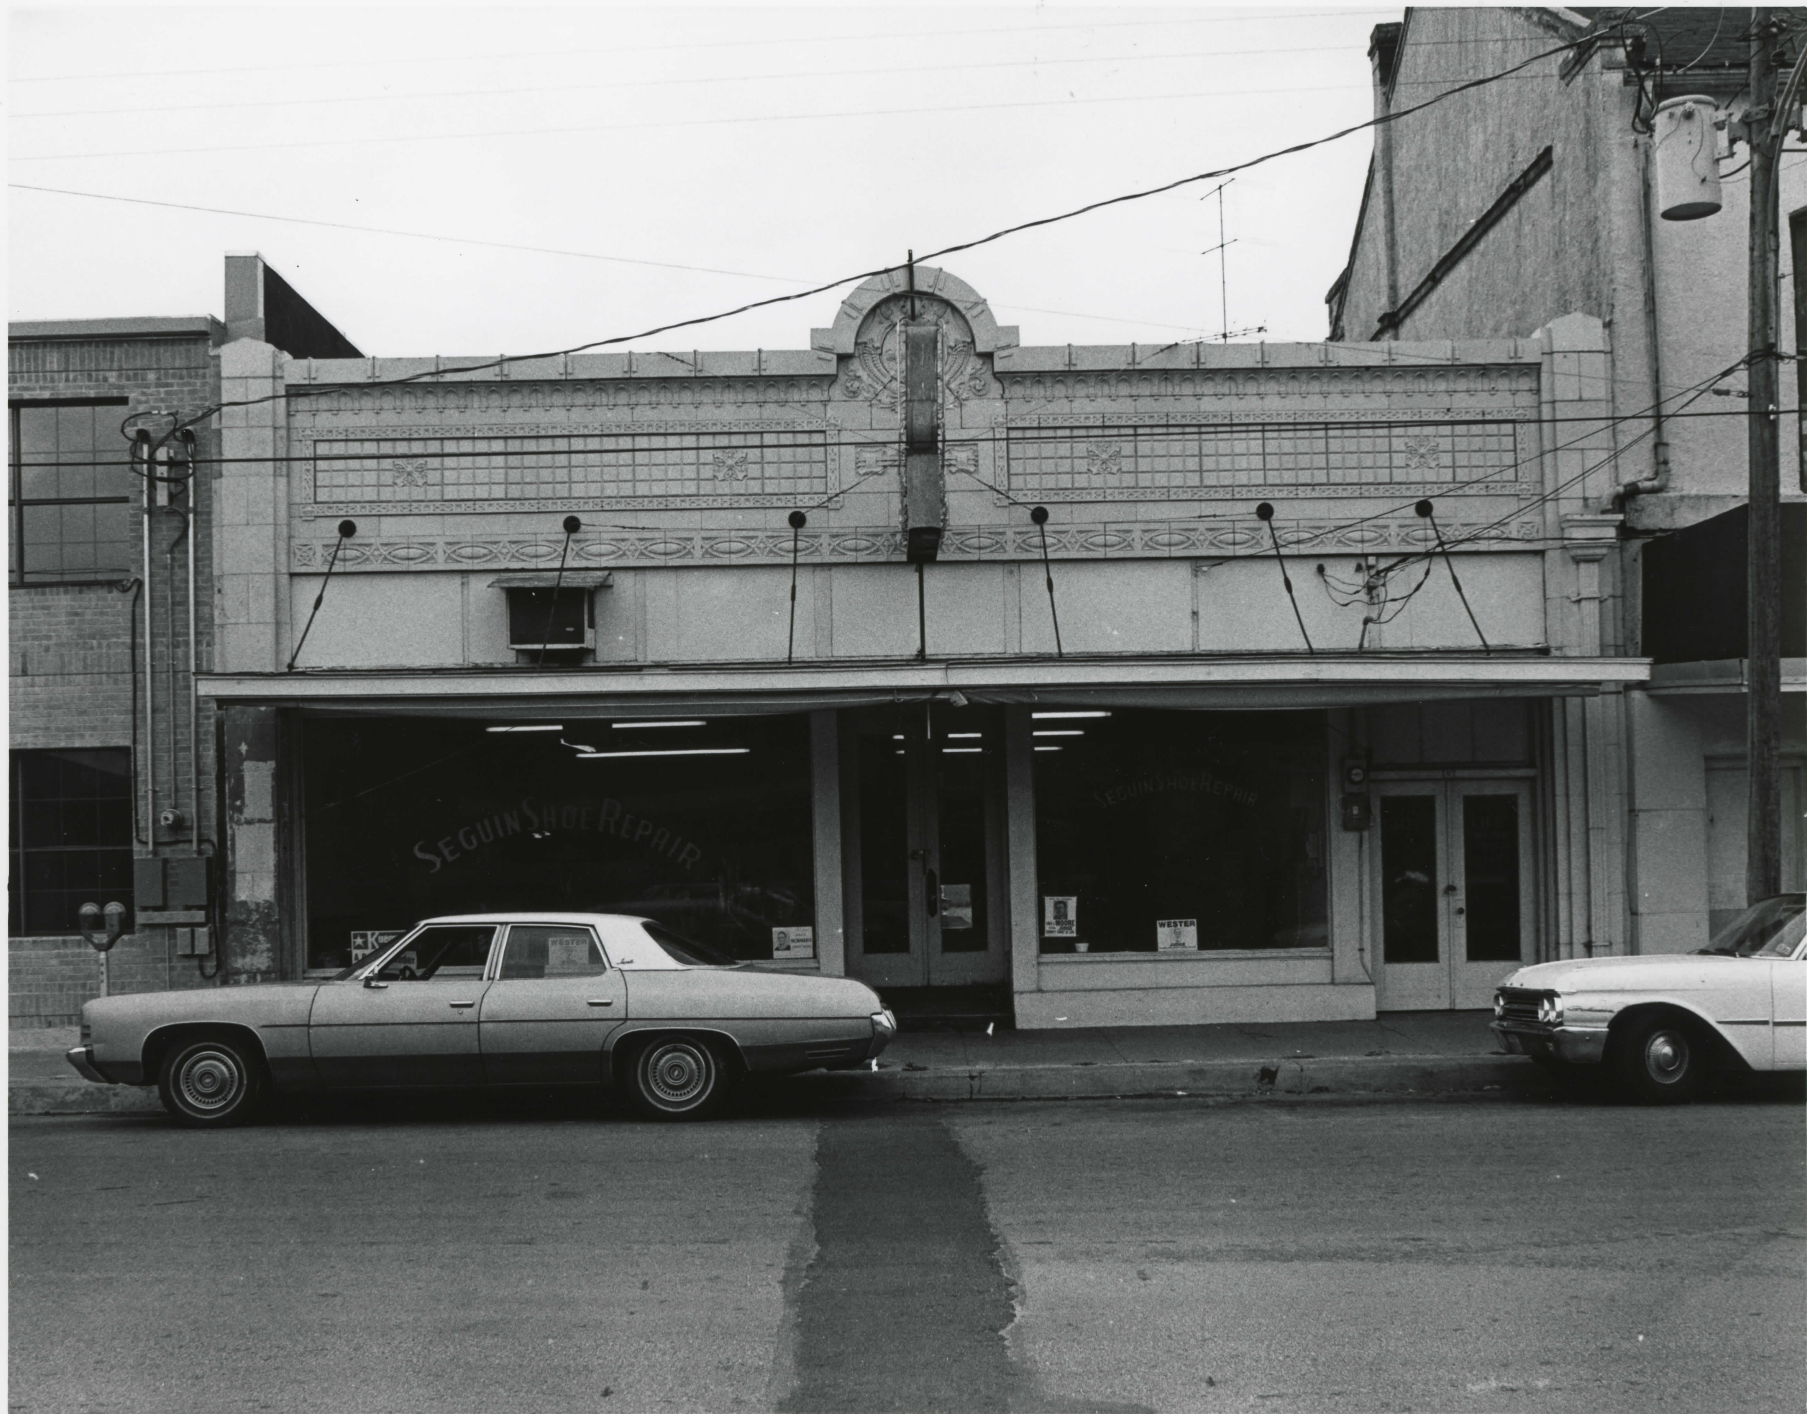
Photo 5 of 19

4. October 1982
5. Site 34, Seguin Shoe Repair, 107-109 N. Camp, Seguin,
6. View to east
7. Photo by Dick Ryan, October 1982; neg. on file at
Texas Historical Commission, Austin

34. 107-09 N. Camp, c. 1896-1930. One-story brick commercial building with a terracotta facade; three-bay storefront with slightly altered central entrance; transom area has been covered. Facade has plain end pilasters, a recessed panel above the transom, and a projecting cornice with corbel table and central arched pediment. Good quality Sullivanesque ornament on upper section of facade. North portion of building burned in 1977. Contributing.

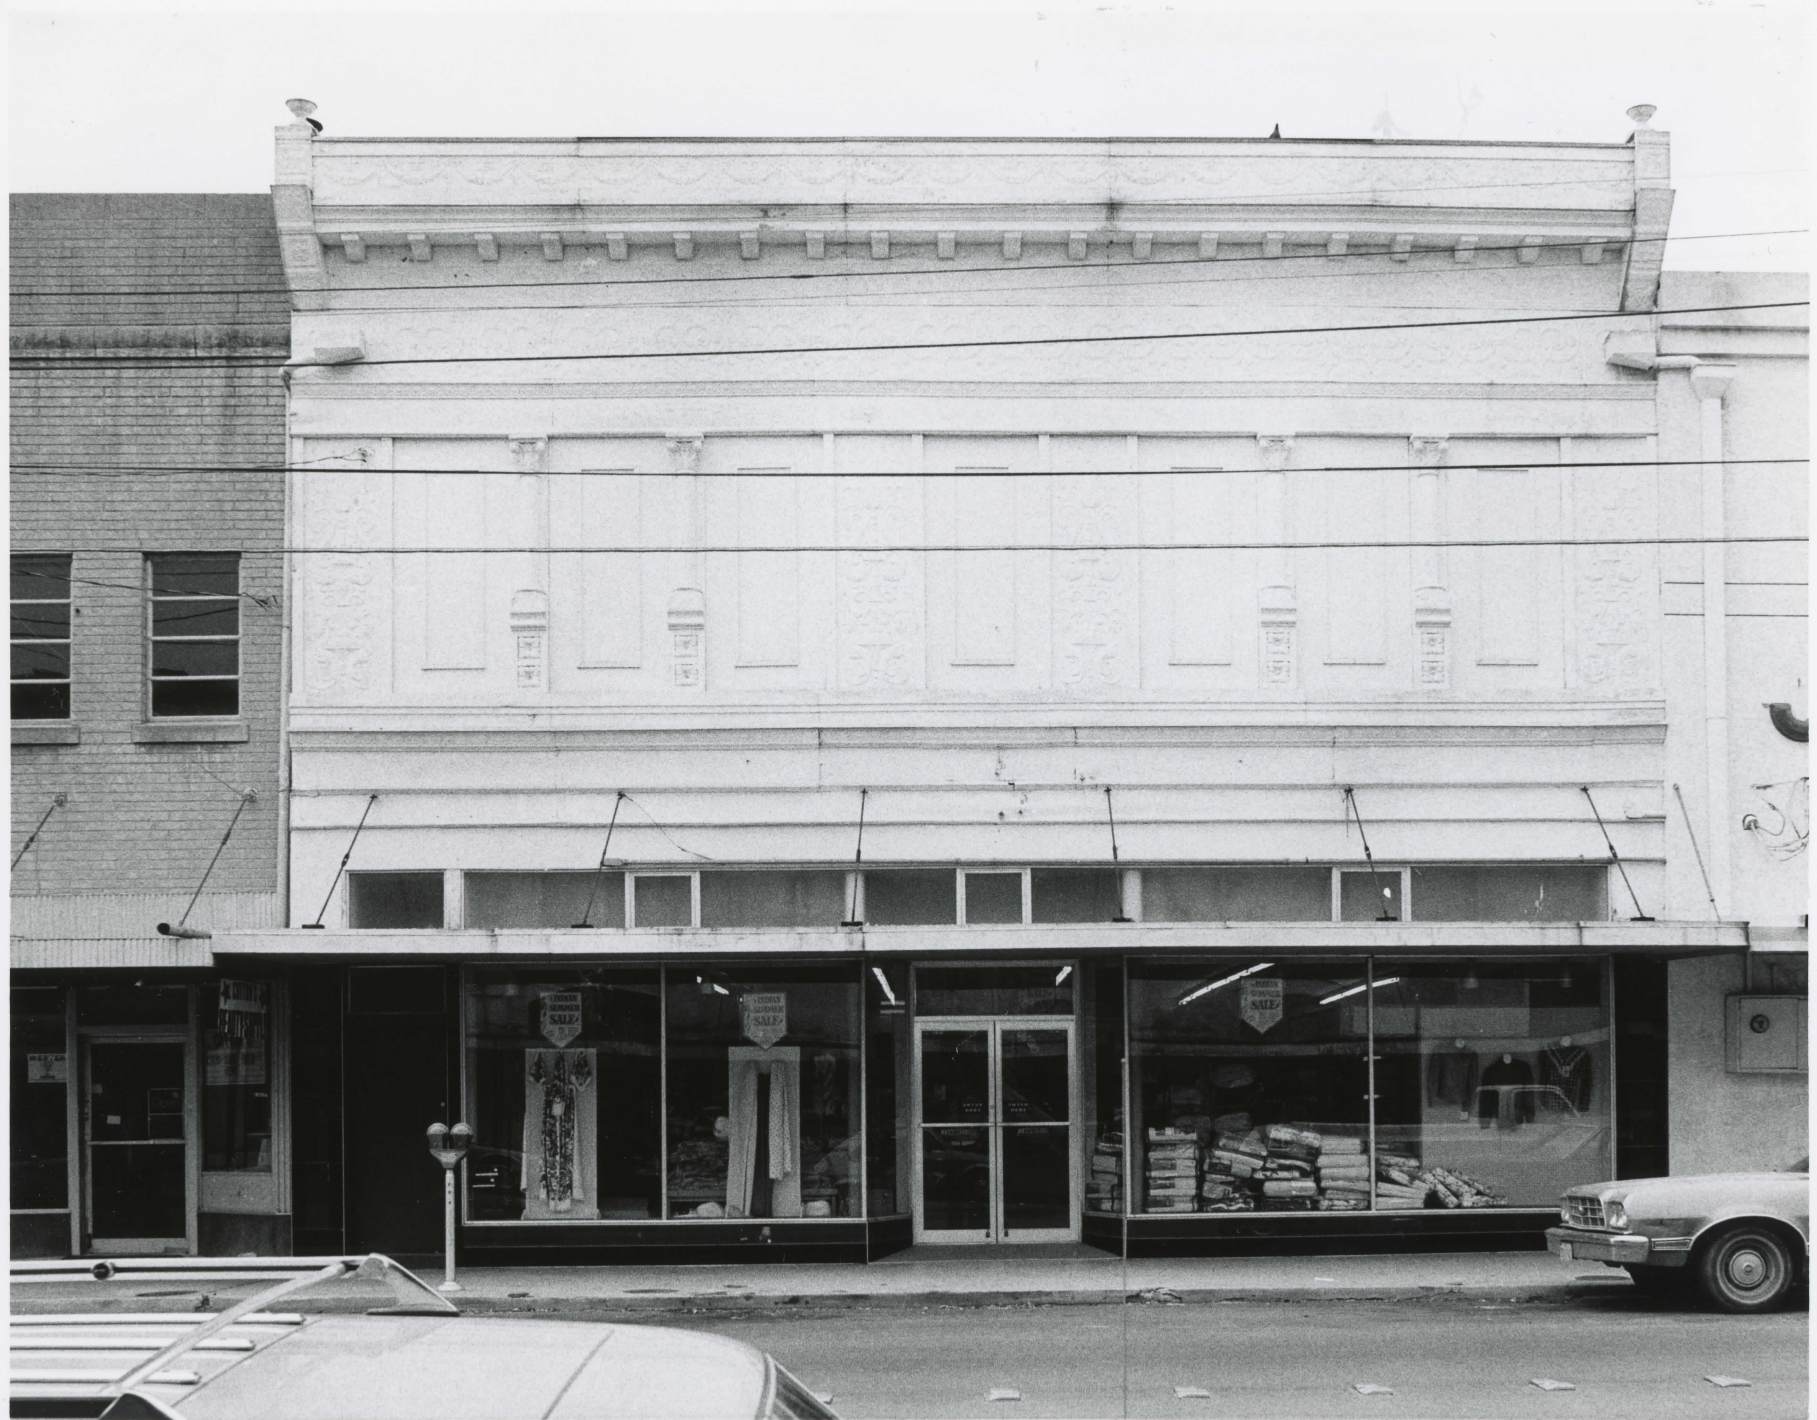
Photo 7 of 19

5. Site 44, Temperance Hall, 104 W. Court, Seguin,
6. Guadalupe County, Texas
7. Roll

This building was built as a meeting hall for the Seguin Chapter of the Sons of Temperance, founded in 1848. Although the ground floor has been modified, the upper story still retains its handsome, pressed-metal cornice. The high relief of the pilasters is an unusual and significant decorative feature.

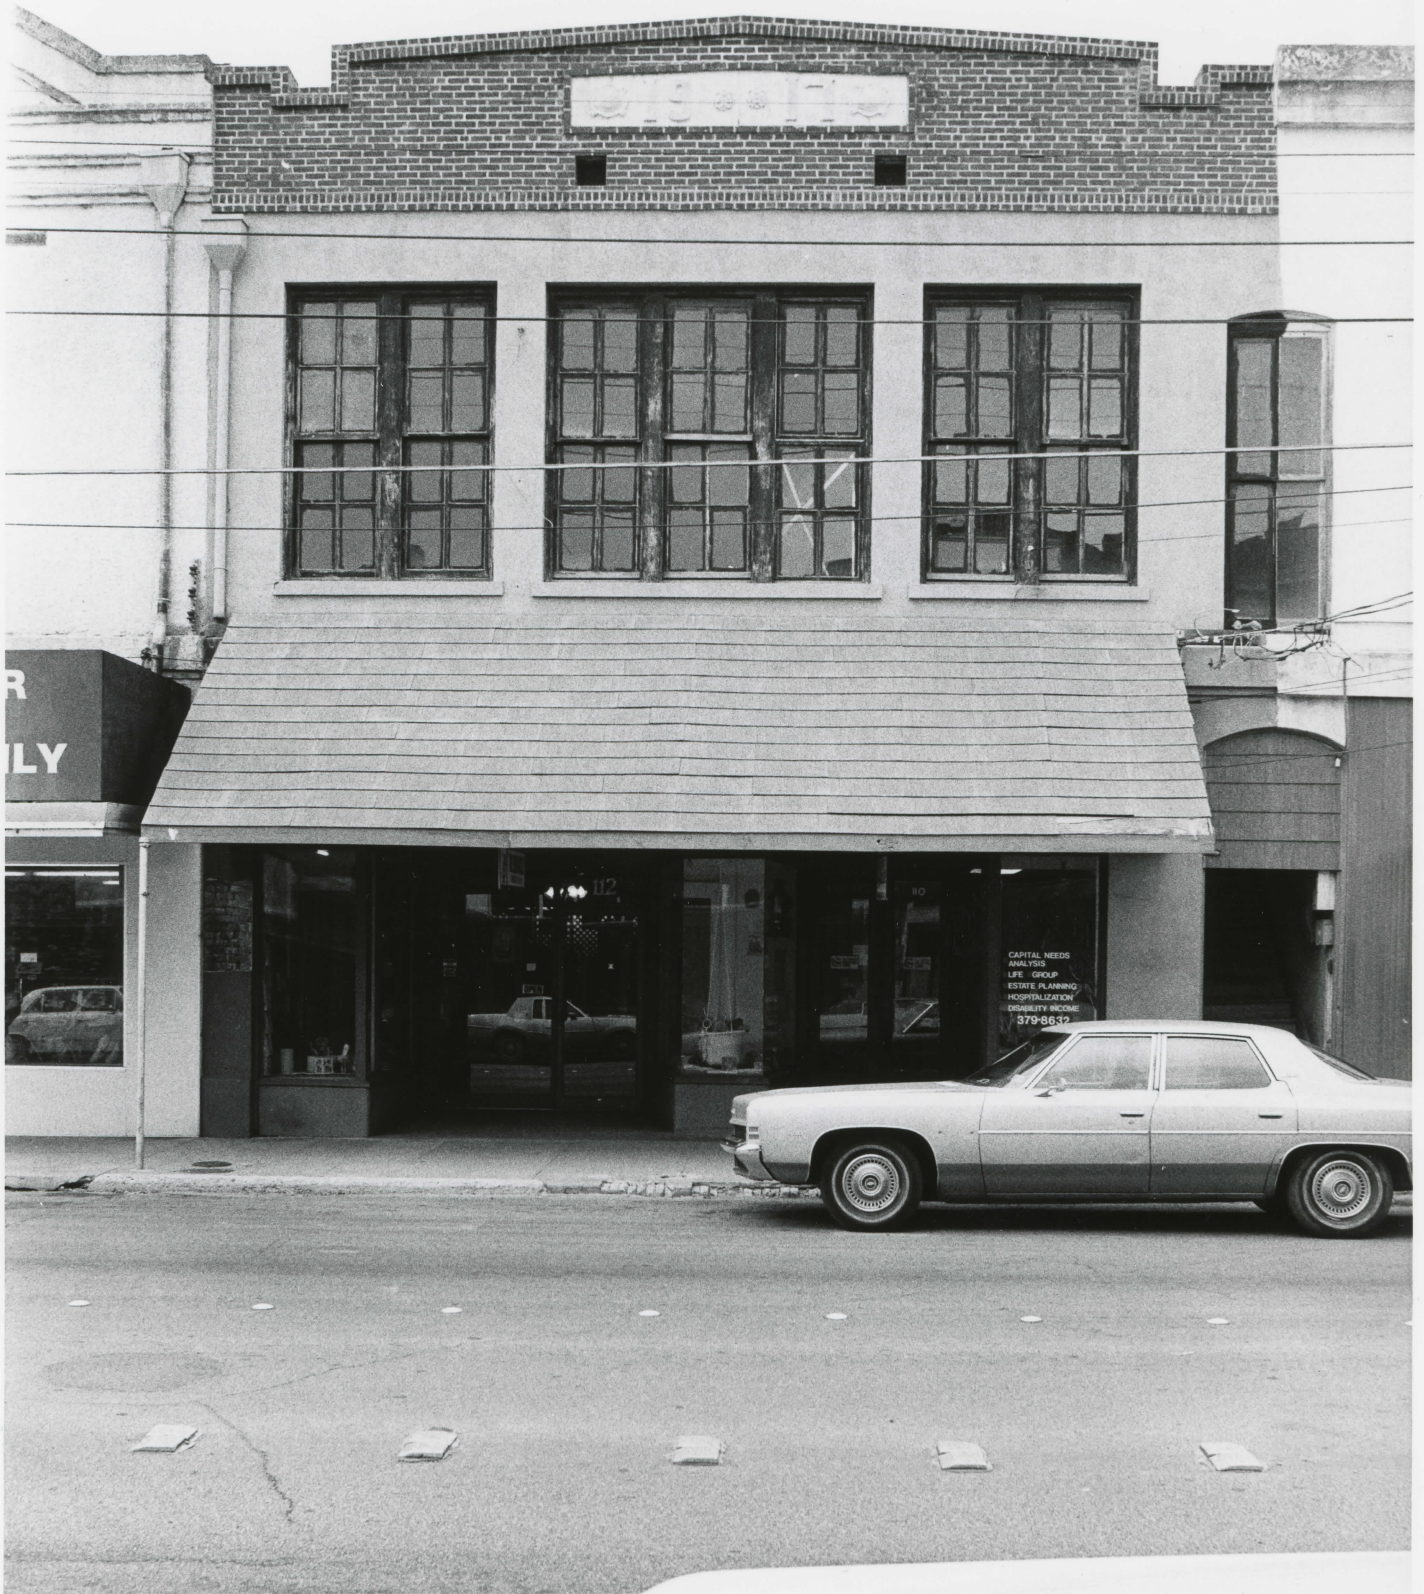
1.
2. 110-112 West Court, Seguin, Texas
3.
4. October 1982
5. Site 47, 110-112 W. Court, Seguin, Guadalupe County,
6. View to north
7. Roll 3; Frame 10A; Site 47
Seguin Commercial District

Site 47, 110-112 W. Court, Seguin, Guadalupe County,
Texas

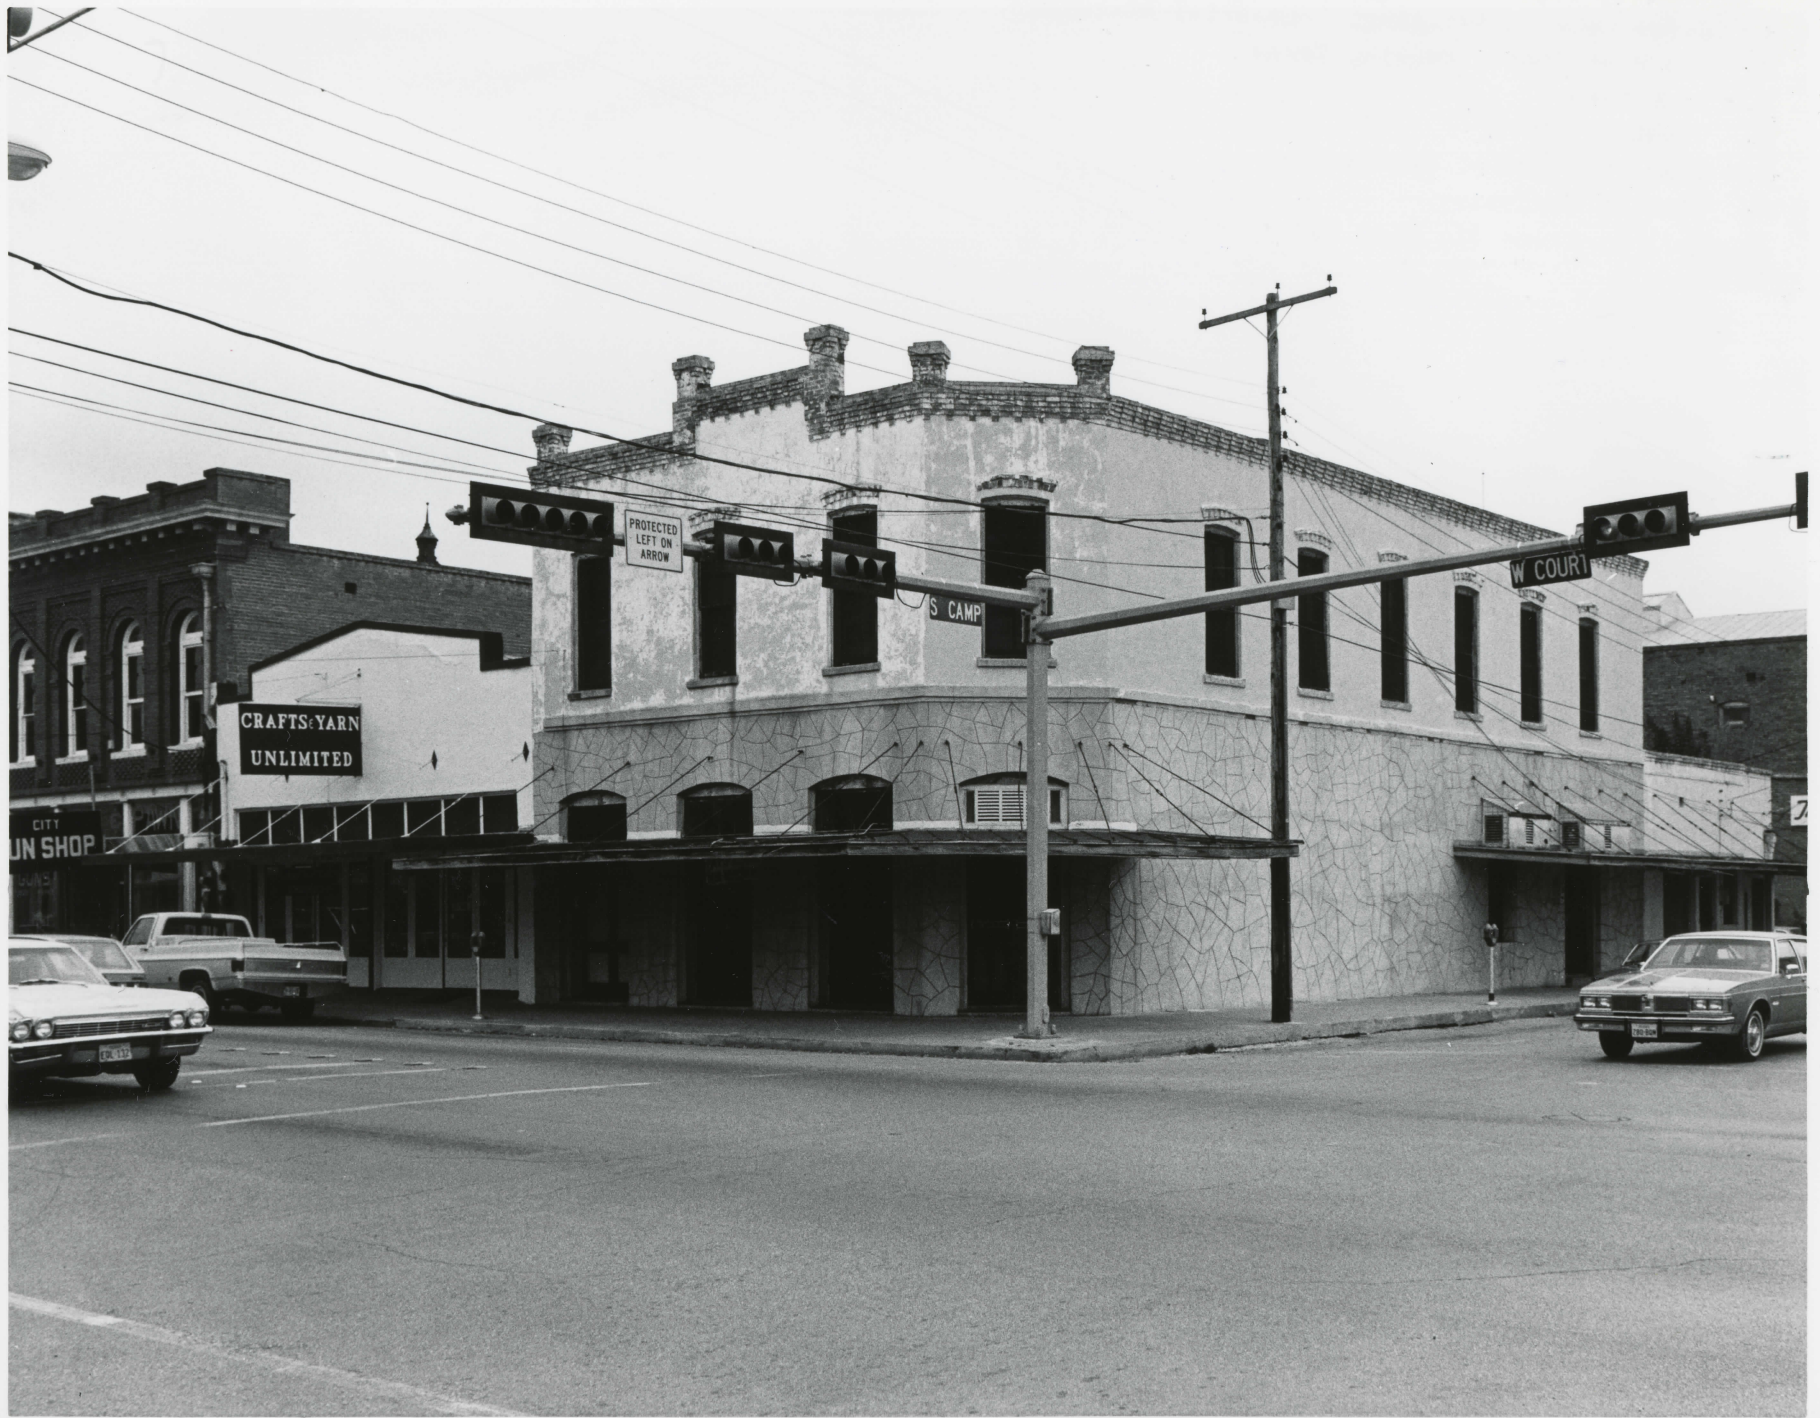
Site 68, LaGette Building, 115 W. Court, Seguin,
Guadalupe County, Texas

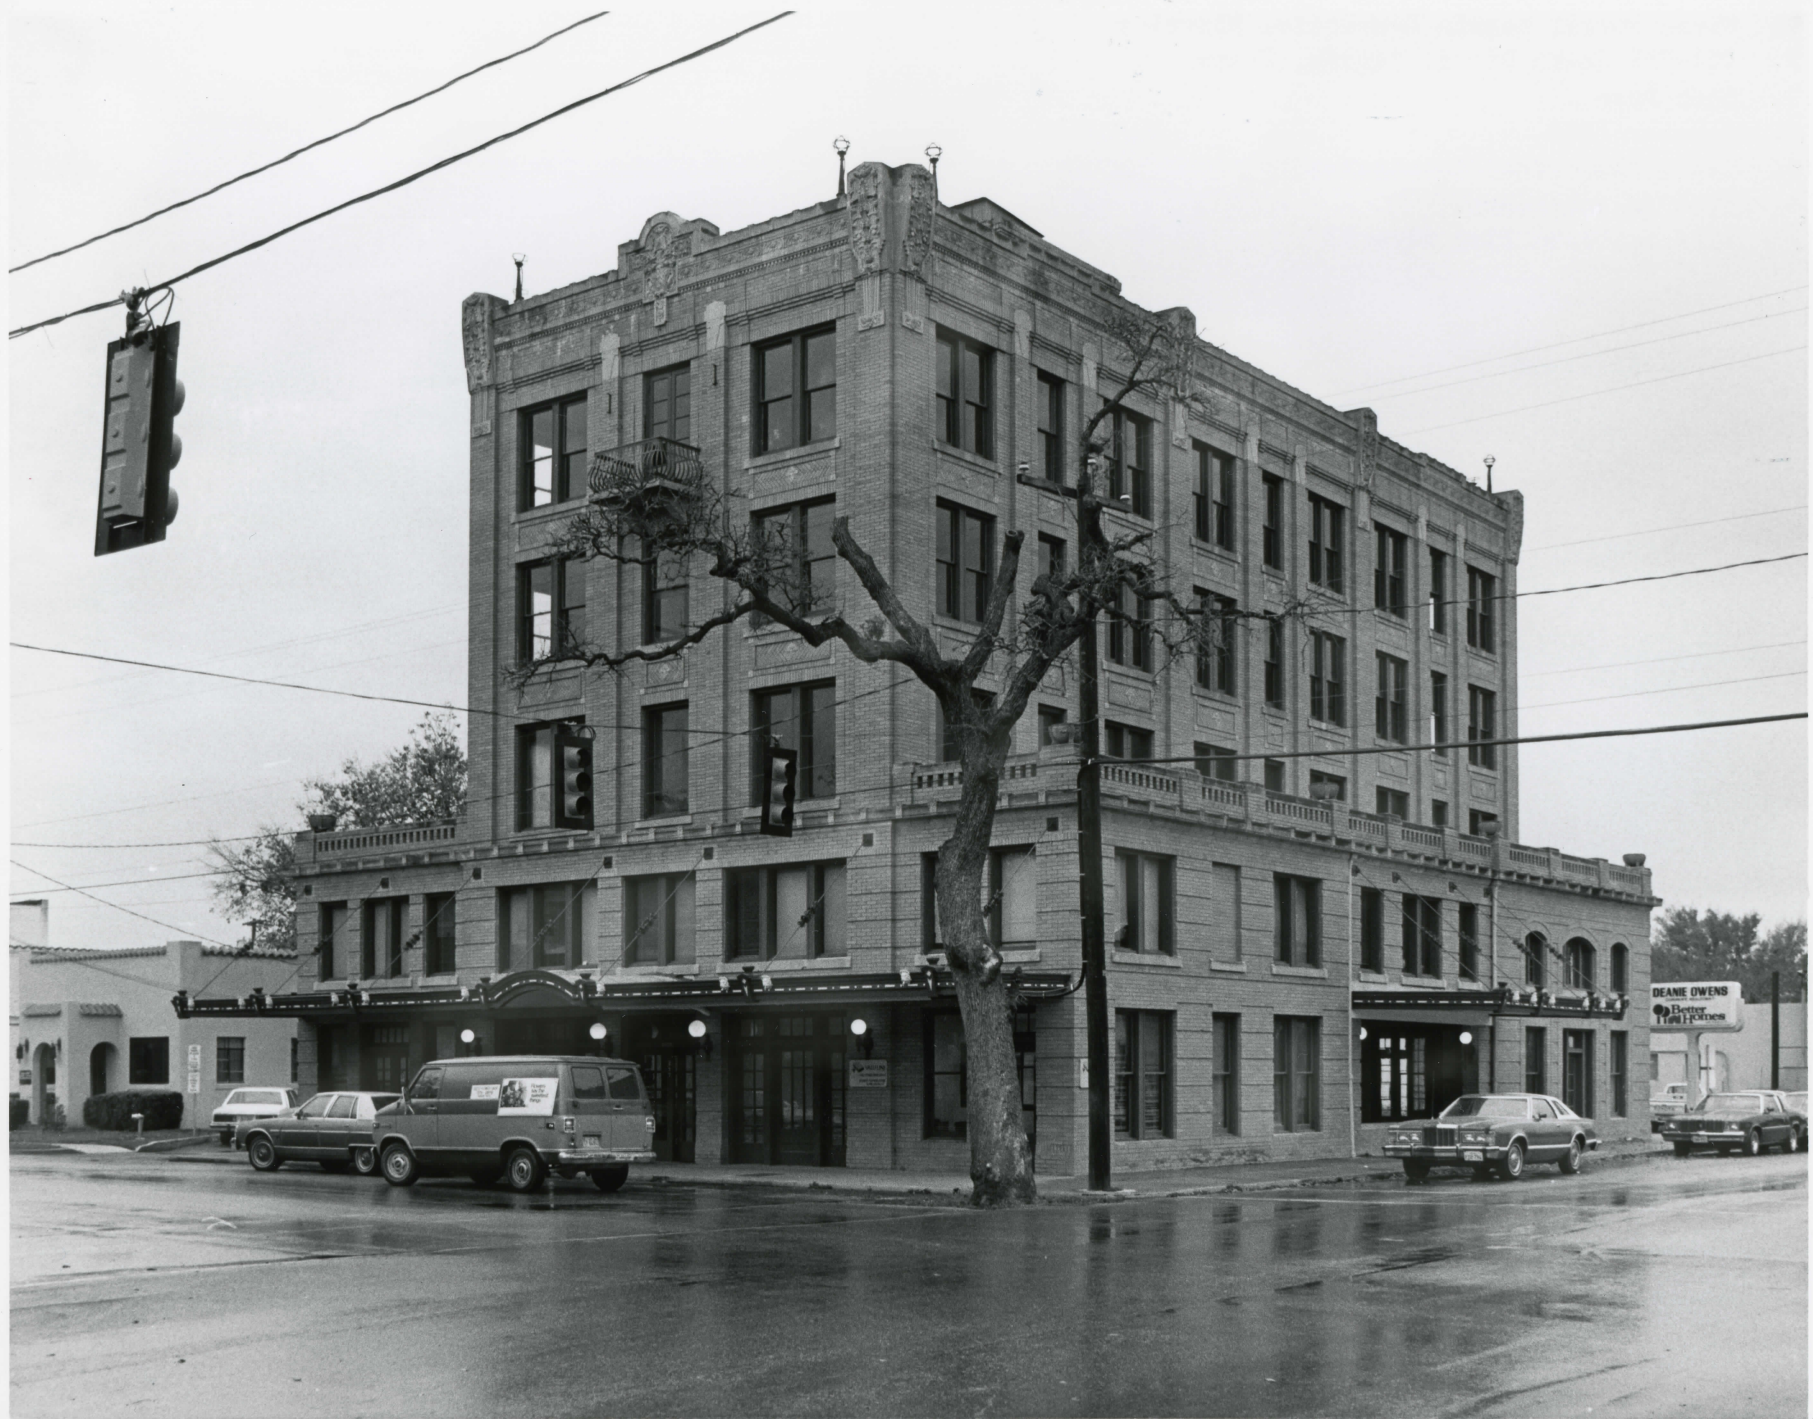
Photo 15 of 19

4. October 1982
5. Site 95, Plaza Hotel, 213-221 South River, Seguin,
6. Guadalupe County, Texas
7. 154 19

94. Public restrooms, Park Square, c. 1960. Small, one-story stuccoed building. Noncontributing.
95. Park Hotel/Plaza Hotel, 213-21 S. River, 1915. Five-story brick Commercial Style hotel. A three-bay wide mass with one- and two-bay ground floor wings. Multiple entrances. Brick of first two floors horizontally rusticated. Brick railing at second-floor level. Upper facade has single and paired 1/1 trabeated windows with paneled spandrels. There is elaborate, Sullivanesque, cast-stone relief at the tops of the structural piers and along the parapet. Designed by noted San Antonio architect Leo Dielmann, the building was listed on the National Register in 1980, and has been partially rehabilitated for use as office space. Contributing.

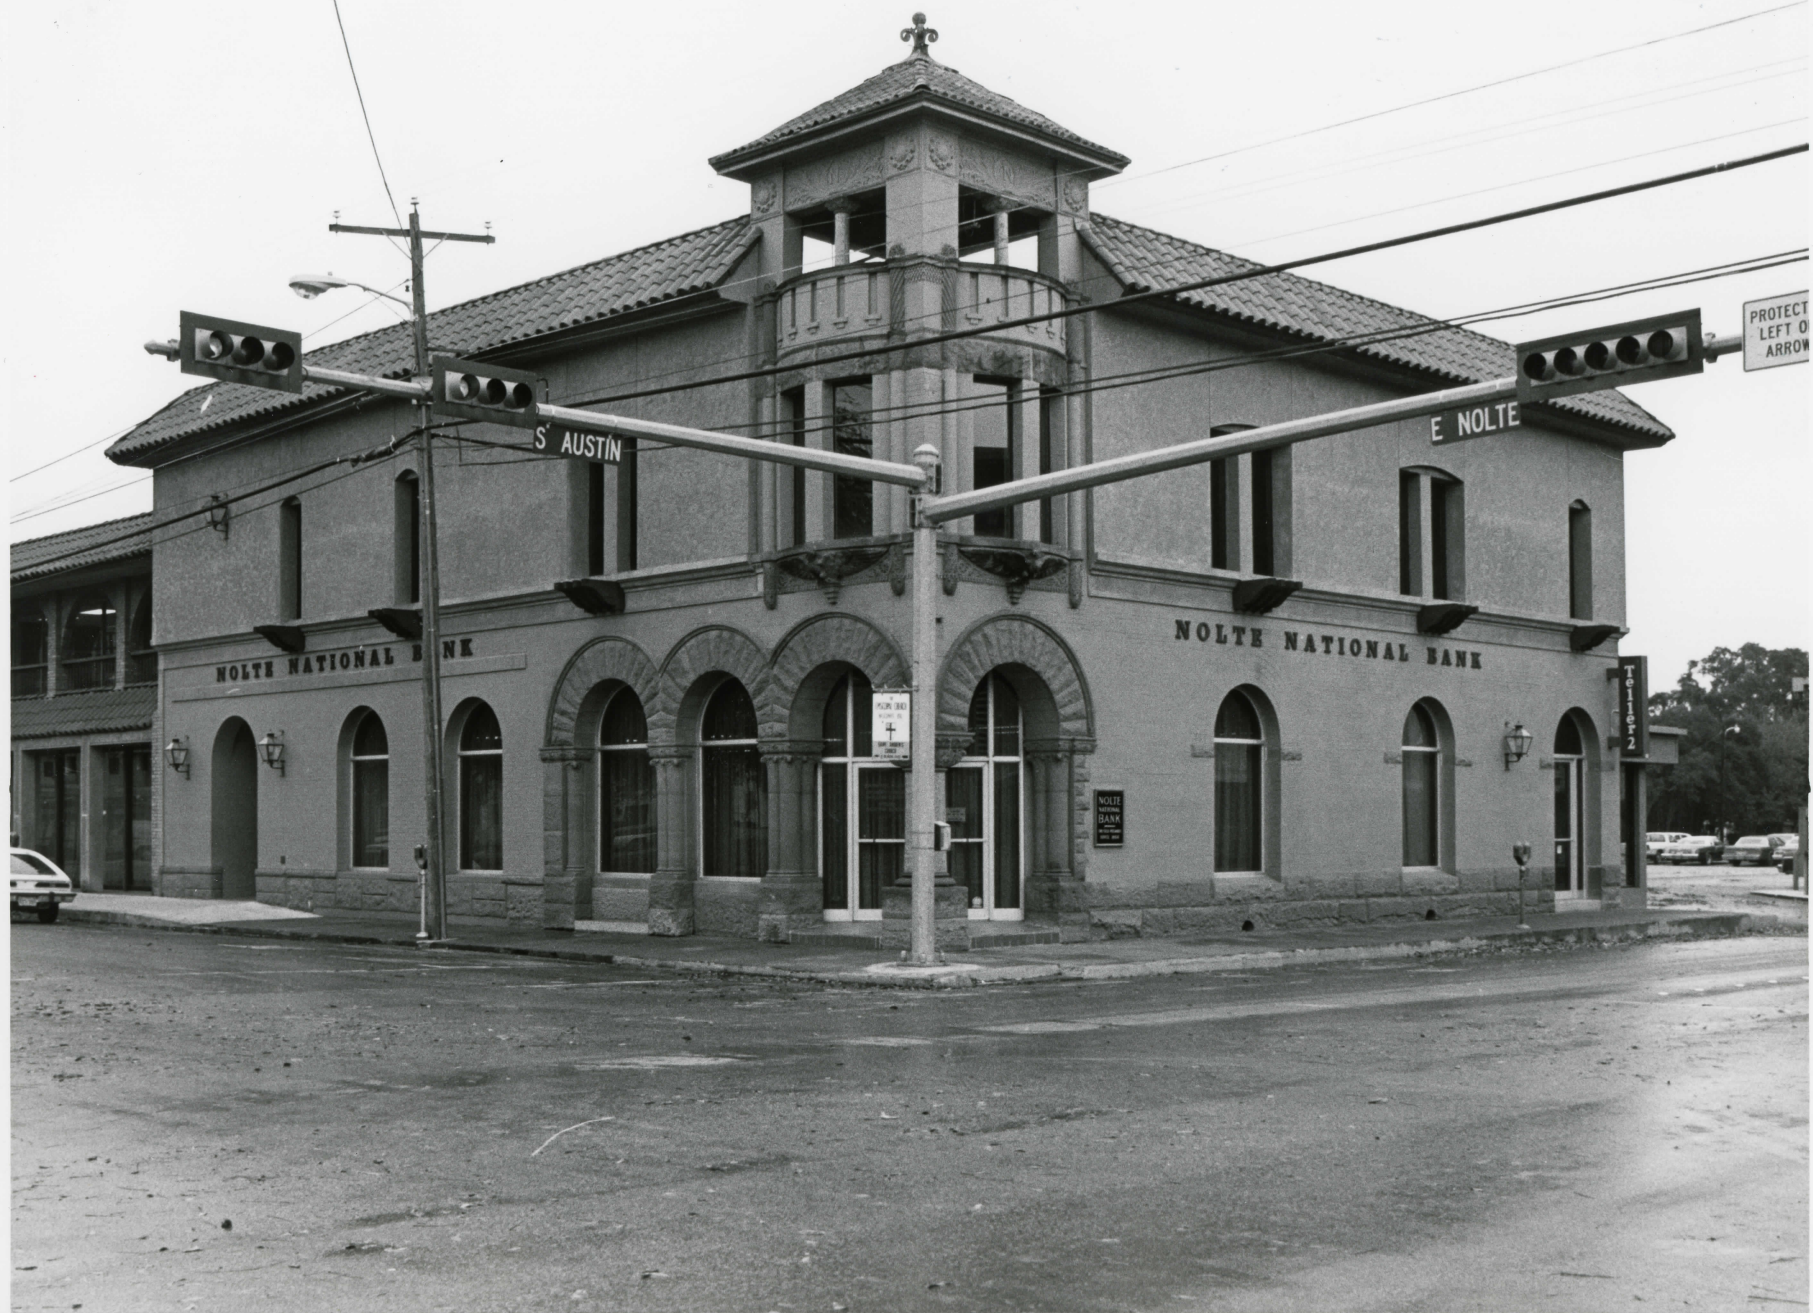
Photo 18 of 19

Site 107-108, Nolte National Bank, 101 East Nolte,
Seguin, Guadalupe County, Texas

- 107-108. Nolte National Bank and additions, 101 E. Nolte, 1898 and later. Two-story brick bank. Round-arch, ground-floor openings; those at the northwest corner form an arcade, with granite colonnettes and rock-faced red sandstone voussoirs. Second-floor, segmental-arch windows single and paired with iron balconies; belt course forms sills. All window glass replaced with one-light fixed sash. The second floor has a square, bracketed, two-stage, hipped-roofed tower over the entrance corner; it has 1/1 windows below and is open at the top. Shed parapet of glazed tile; tower roof also glazed tile. The building has been stuccoed.

- Eduard Nolte began the bank in his store about 1868. Moving to this building, it continued as a private bank until receiving a charter in 1936. The building was remodeled c. 1939 and again in 1947, when a drive-in was built. It was expanded to the east in 1966, and again in 1973. In 1980 a motor-bank annex was built (#111). The additions carry out the Spanish Colonial theme of original building, which replaced the original Richardsonian Romanesque program. Original section designed by J. Riely Gordon, architect. #107 contributing, #108 noncontributing.

One of several buildings built by the Nolte family in the district, the bank was erected in 1898 from designs prepared by the noted architect J. Riely Gordon. The corner entrance tower is highly detailed, in a Romanesque Revival manner, with a round-arch arcade at the base. The bank was founded in 1868 by Edward Nolte, and operated as a private bank until it was chartered in 1936.
